**Sonning Lock  
Thames Path  
Reading  
RG4 6SU**

## **Arboricultural Report**

### **Tree Inspections**

**Report Ref: VMS 1726**

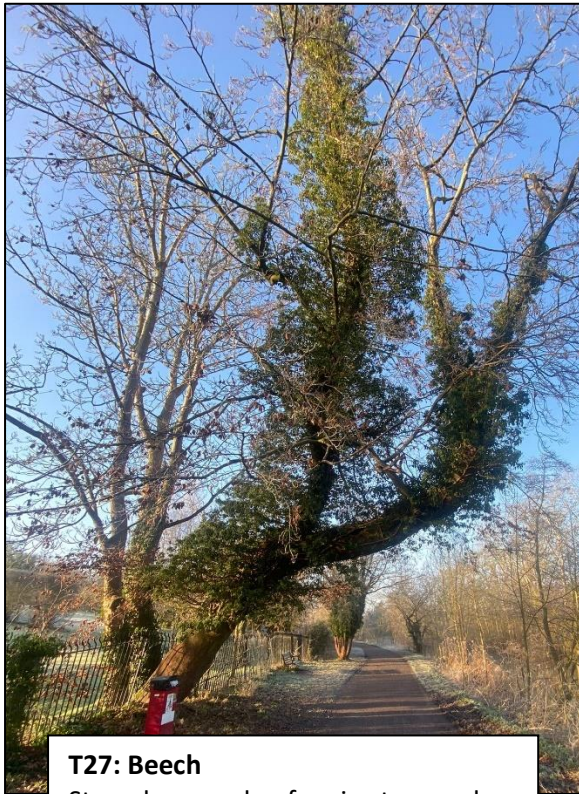
This tree is listed on the Health and Safety Duty of Care Report as a Linden, however upon inspection was correctly identified as a Beech. The tree had Ivy covering the main stem, which was removed prior to arrival to allow accurate inspection. There is a large limb which extends horizontally above the towpath access road which has been struck by a high sided vehicle causing surface damage to the bank. The weight distribution of this tree is biased towards the towpath and river on the North West aspect. Crown vigour could not be assessed due to time of year, but there appeared to be an even distribution of leaf buds in the crown.

**T27: Beech**  
Steep lean angle of main stem and low limb over access road

The presence of extensive decay in the main stem of this tree along with its location along a heavily used towpath results in the requirement to remove to ground level to alleviate risk potential. This work should be carried out within one month of submission of this report. Any weight reduction work to the crown in an attempt to prolong its usable lifespan may add further stress to a tree of declining health. The use of the main stem as habitat potential was suggested, however due to the lean angle of this stem, it would pose a future hazard as remaining timber loses its structural stability in both roots and stem, with minimal observable signs of deterioration, adjacent to a heavily used public right of way. To improve ecological material for the area, it is recommended that this stem be felled to ground level, and the stem left whole in the adjacent grass area.

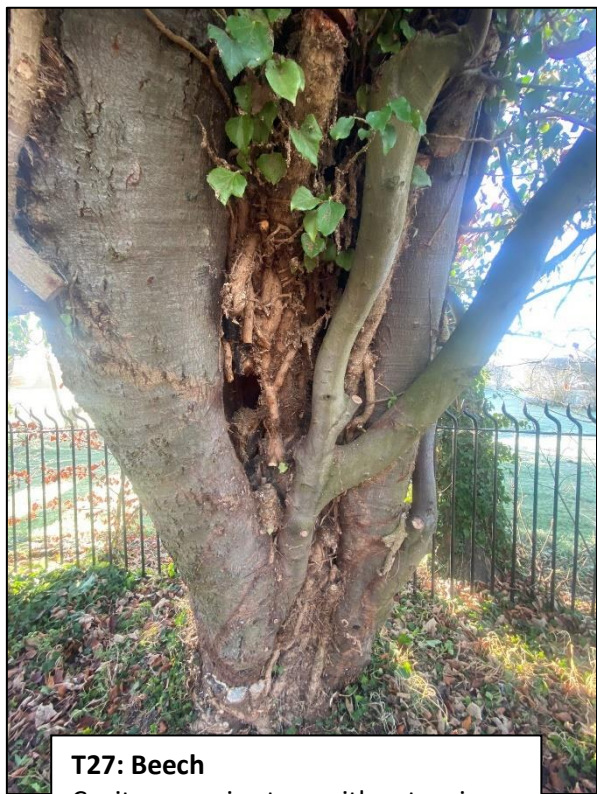
Located on the Northwest face of the main stem from ground level to approximately 2m is a cavity with extensive decay presence. The results from the acoustic hammer testing revealed the presence of deteriorated timber on the Southeast face of the main stem. This area is concealed behind bark with no obvious signs of defect. This would suggest that poor quality timber makes up a large percentage of the main stem and so effects the structural integrity of the main stem near ground level. This level of structural defect presents enough evidence to recommend removal of the tree, and so there was no requirement to further investigate from an elevated position and perform inspections at height.

**T27: Beech**  
Cavity on main stem with extensive decay presence

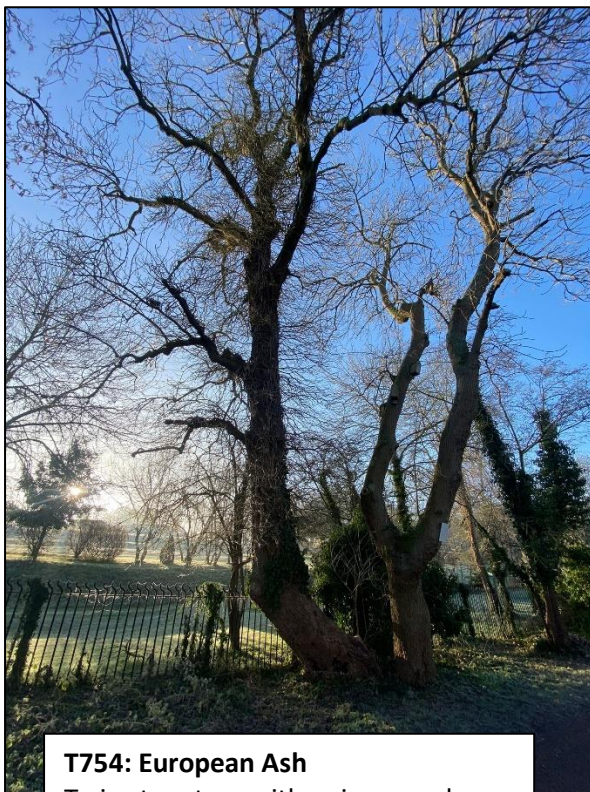
This tree is located between the towpath and the neighbouring property along the access to the lock. It has a main union point at approximately 0.5m with one stem growing at a steep angle to the side before turning vertically and growing upright. The tree had Ivy covering the main stems and around the base, which was removed prior to arrival to allow accurate inspection. There is evidence of bark damage near to ground level on the Northwest face of the leaning stem, with a shallow void between remaining bark and heartwood. There was no evidence of fungal presence at the time of survey around this area or obvious reason for the bark damage. The use of a nylon headed hammer to test acoustics of the timber around the base revealed no areas of concern. The acoustic sounds created appeared consistent with that associated with normal condition timber.

**T754: European Ash**  
Twin stem tree with union near base.

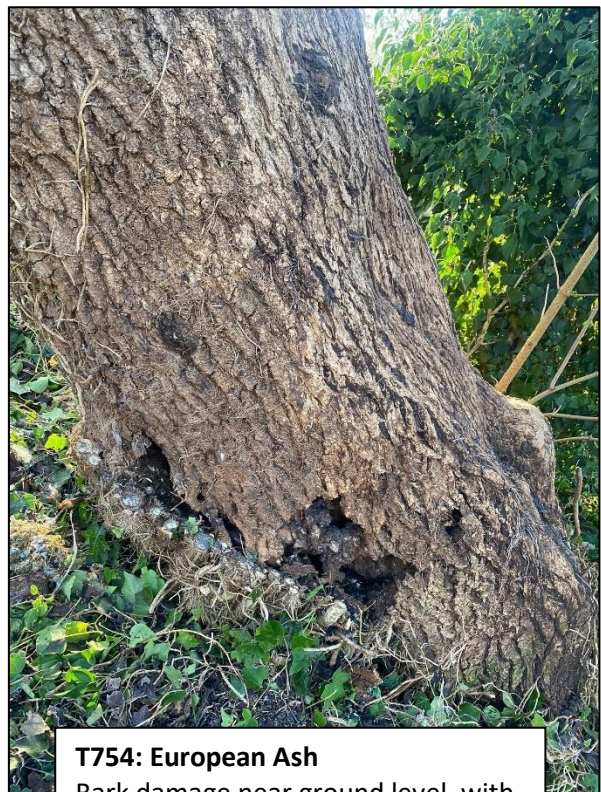
**T754: European Ash**  
Bark damage near ground level, with localised decay presence.

As a result of the lack of evidence to diagnose the bark damage near the base of this tree, it is recommended that further investigations are carried out at different times of year, which may provide different findings and construct a better diagnosis for the tree. Due to the potential for Ash dieback (*Hymenoscyphus fraxineus*) it is advised to re-inspect the tree in early summer months when the tree is in full leaf coverage, which will aid in identification of leaf wilt and overall crown vigour. This visit may also identify potential early stages of fungal brackets around the damaged bark near the base if they are present.

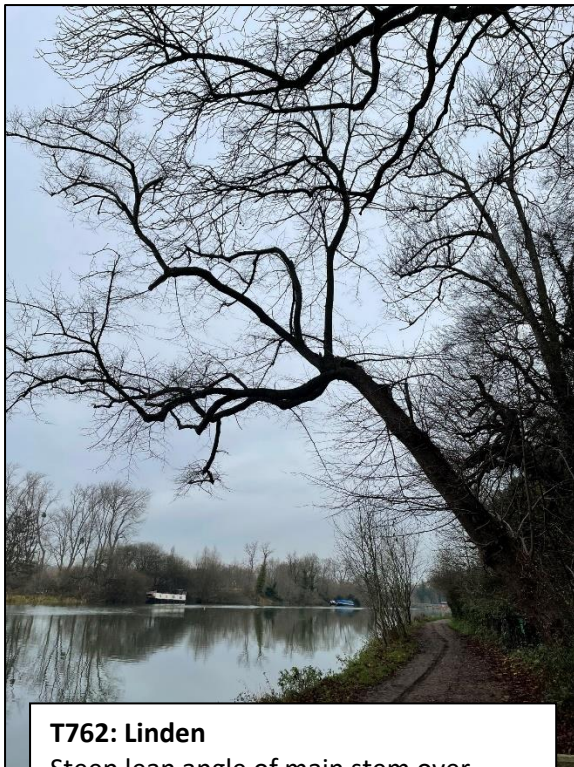
**T762: Linden**

This tree is located adjacent to the towpath which borders a wooded area to the East. The tree has a steep lean angle above the towpath and adjacent river which is likely due to light suppression when establishing in this area. This observation is supported by the presence of no signs of rootplate movement or lifting and no noticeable defects on the main stem as a result of movement. There are multiple small diameter cuts to the previous epicormic growth near the base of the stem, and a heavy build up of leaf litter between these small pegs. Where possible this leaf litter was removed to closer inspect basal areas and buttress recesses. There were no observable signs of defect on this tree, however the lean angle and target potential raises concern.

Steep lean angle of main stem over towpath, likely due to light suppression.

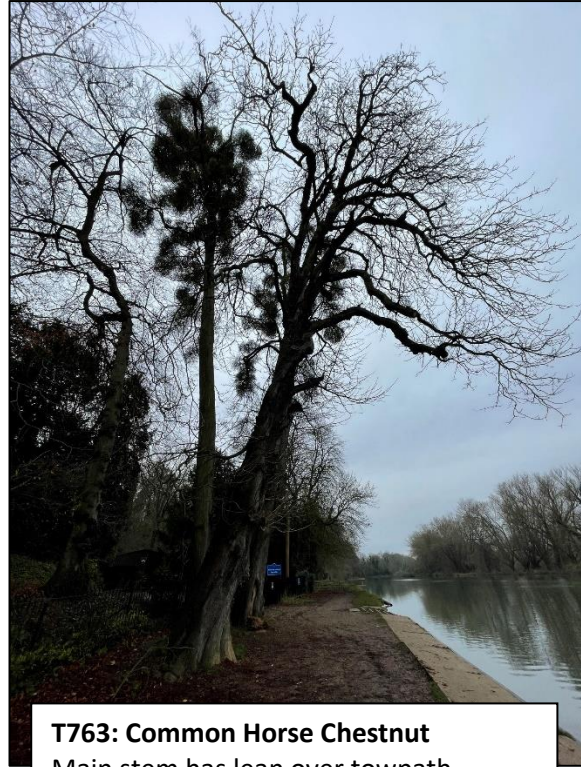
**T763: Common Horse Chestnut**

This tree is location adjacent to two Lime trees along the towpath and adjacent to neighbouring property access gates. It has a lean angle towards the river and over the towpath which is likely due to light suppression from other adjacent trees and wooded areas. The basal inspection identified a cavity with the presence of decayed timber within, which is located on the Southeast side of the main stem. The use of a nylon headed hammer to test acoustics of the timber around the base revealed some deteriorated timber in one buttress root and within the immediate vicinity of the cavity. The remaining stem at the base resulted in no obvious areas of concern and the acoustic sounds created appeared consistent with that associated with normal condition timber. It was not possible for the metal probe used to penetrate passed the decayed wood surface within the cavity and so an accurate measurement of extent of decay was not possible. Due to concerns raised over the condition of historic pruning wounds within the crown of the tree, and aerial inspection was carried out using a MEWP. These pruning wounds have decay present, likely due to the large size of the limbs removed and speed of healing in a declining tree. The largest of the aerial cavities located on the West aspect extends approximately 200mm deep, with likely deteriorated wood continuing passed this point. The extent of this decay is unknown without further investigation in the form of invasive of scanning, however there is substantial stem timber in this location to suggest localised decay wouldn't affect stem stability at this stage. This diagnosis is the same for the remaining smaller decay pockets within the crown and on the stem, but on a smaller scale. Collectively these decay pockets will have a negative affect on the stem stability if faced with lateral forces applied from events

Main stem has lean over towpath

The decay pockets identified at the base and in the crown of this tree have raised concerns over its stability with regard to the target potential. Any further development of decaying wood could result in base or stem snap and all resulting debris would likely land on the towpath. The extent of the decay at the base and in multiple areas within the crown is unknown without further investigation in the form of invasive or scanning, and so likelihood of failure cannot be estimated. Any weight reduction work to the crown in an attempt to prolong its usable lifespan may add further stress to a tree of declining health and may speed up the decline process. It is recommended that this tree be removed to

ground level to alleviate risk potential within one year of submission of this report. This timescale is solely recommended to alleviate the visual and ecological impact on the surrounding area when multiple trees of this size are removed. It is likely that the identified decay pockets within this tree are at a tolerable percentage when compared to adjacent healthy wood and so the priority for removal of this tree is as stated.

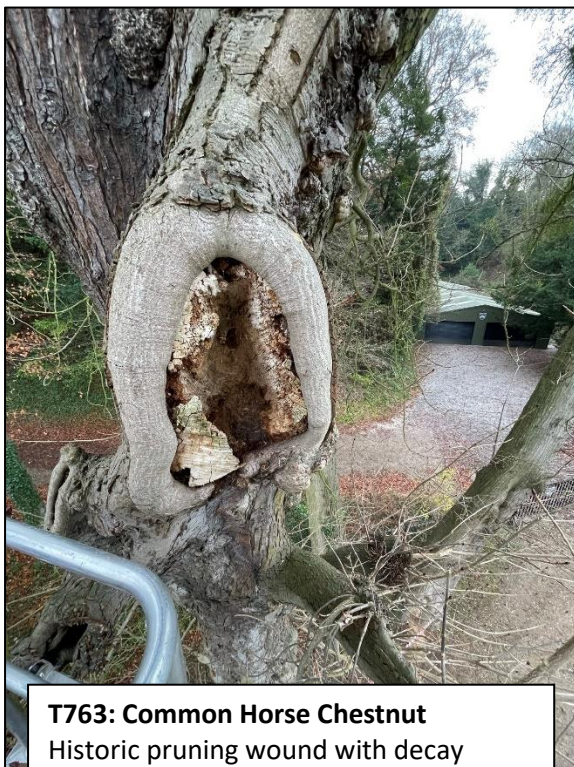
**T763: Common Horse Chestnut**

Historic pruning wound with decay presence. Void extends 200mm from pruning surface.

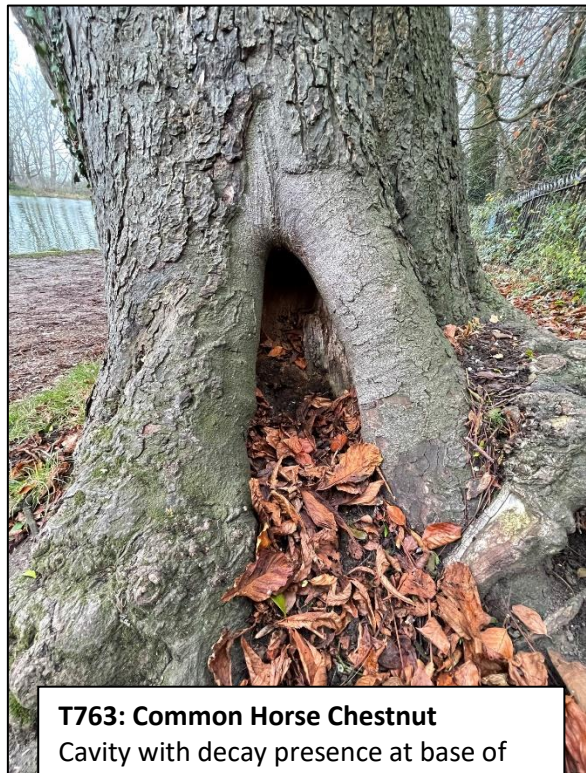
**T763: Common Horse Chestnut**

Cavity with decay presence at base of tree, and buttress with potential deteriorated timber

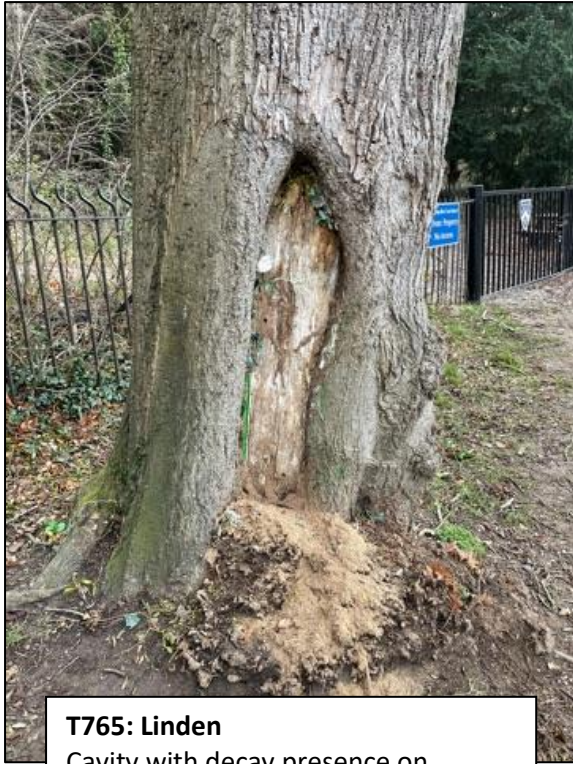
**T765: Linden**

This tree is located adjacent to T763 on the towpath and incorporated a manmade wooden structure within a potential cavity on the Northwest aspect. This wooden structure was removed prior to arrival to carry out the inspection. There is a large cavity with extensive decay present at the base of this tree which the wooden structure was concealing. This decay extends through to a second cavity on the Southeast aspect which was confirmed by using a metal probe. The use of a nylon headed hammer to test acoustics of the timber around the base supported the visual findings of decay presence, and the extent within the stem. Evidence would suggest that a large percentage of the stem of this tree has decay presence, which will negatively affect its structural stability. Concerns were raised over a potential cavity within an old pruning wound at approximately 4m, however aerial inspection via a MEWP identified that decay was localised to surface wood only within the pruning area.

Cavity with decay presence on Northwest aspect

Due to the extensive decay present within the main stem of this tree, and its location on a heavily used towpath it is recommended that it is felled to ground level to alleviate potential risk. This should be carried out within one month of submission of this report.

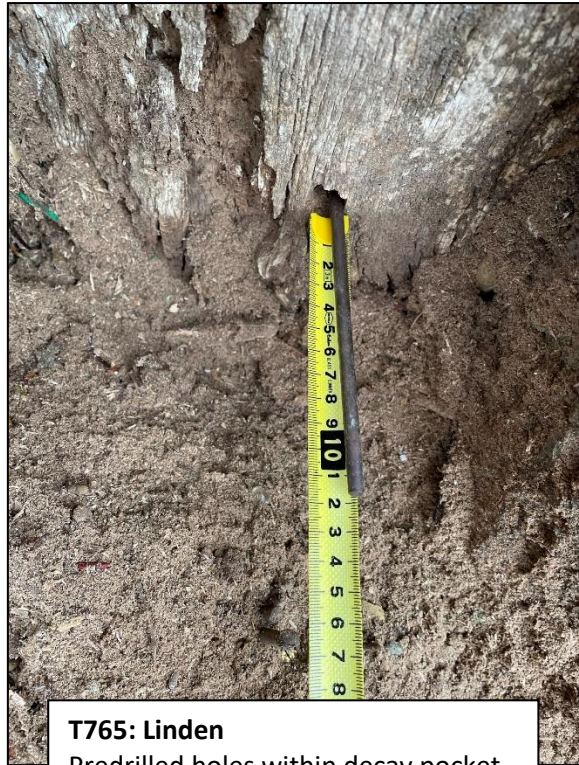
**T765: Linden**

Predrilled holes within decay pocket on Northwest aspect probed to a depth of 250mm.

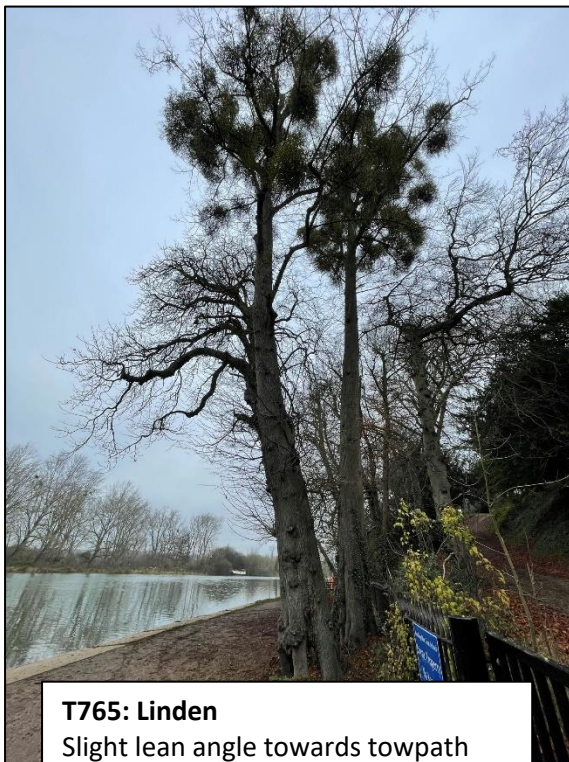
**T765: Linden**

Slight lean angle towards towpath and river, and the presence of mistletoe in the upper crown.

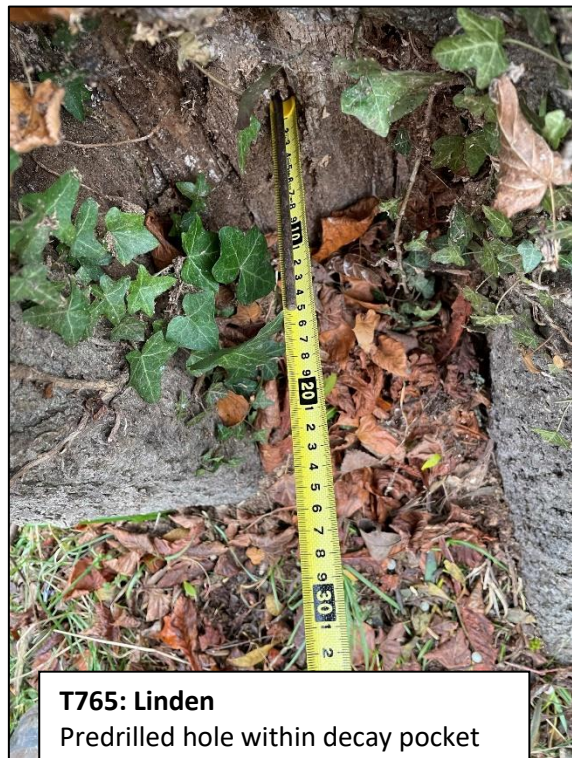
**T765: Linden**

Predrilled hole within decay pocket on Southeast aspect probed to a depth of 220mm.
